Prabhakaran M, Jeyasimman D and Varatharajulu M
Investigation of the failure mechanism of dissimilar resistance spot welding of steels.
Emerging Materials Research,
<https://doi.org/10.1680/jemmr.22.00224>

Investigation of the failure mechanism of dissimilar resistance spot welding of steels

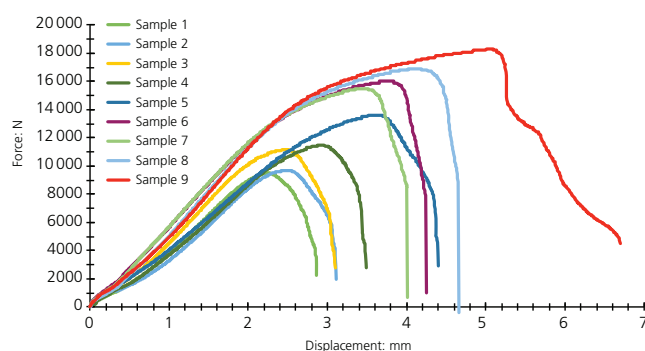
In the TST, nine samples were tested, and the tensile shear characteristics of the welded specimens could be inferred by studying the load–displacement curves shown in Figure 2. The results show that sample 9, followed by sample 6, absorbed the

Figure 2. Load–displacement curve of the TST. This figure was reproduced with permission from the publishers of the paper by Prabhakaran *et al.*¹¹

maximum shear load before failure. Samples 9 and 6 failed after withstanding tensile forces of 18 and 16 kN, respectively. The investigation of the tensile-shear-failed samples showed that all the samples except one failed under interfacial mode and sample 9 failed under button pull-out failure mode. A similar inference has been obtained for dissimilar RSW of TWIP steel with austenitic stainless steel.¹⁷ However, in a study of dissimilar welding of austenitic SS 316 and titanium alloy by Taufiqurrahman *et al.*,¹⁸ wherein the welding current ranged between 11.0 and 13.0 kA, all the samples failed under interfacial mode during the TST. This reveals that the failure mode is not purely dependent on the welding current and nugget size but is also dependent on the metallurgy of the parent metals. The current research also reinforces the fact that an austenitic stainless-steel specimen welded with a welding current above 7.5 kA results in pull-out failure mode.

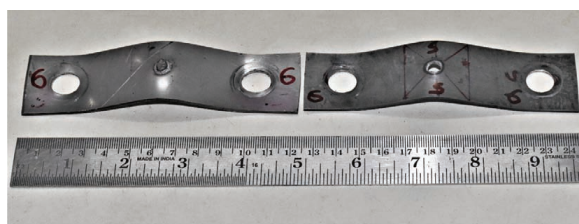
mechanism of the samples during the CTT. In sample 6, the crack initiated from the nugget and then propagated around the circumference, resulted in a partial pull-out failure. As seen in Figure 5, the weld nugget is not fully separated and there are evident signs of fracture through the nugget area. The fractography images shown in Figures 7(a) and 7(b) show the upper and lower surfaces of fractured sample 6. The SEM images of the fractured surface show the formation of cleavage facets, and thus, the fracture mode is found to be brittle. Reinforcing the same inference, the load–displacement curve of sample 6 in Figure 8 also shows the failure mode as brittle. This also agrees with the results obtained by Marashi *et al.*²³ that nuggets with a diameter smaller than the critical value of $4t^{1/2}$ fail through interfacial mode only. Upon investigation of the failure mechanism of sample 9, Figure 6 shows a complete separation of the nugget from its counterpart, which means the failure mode is button pull-out. The fractography images in Figures 7(c) and 7(d) show upper and lower surfaces of the fractured surfaces of sample 9, and the presence of cleavage facets on the lower surface is a

Figure 5. CTT-failed sample 6

fixture shown in S7 in the online supplementary material. This fixture in turn was mounted on the Tinius Olsen H50KL tensile-testing machine shown in S8 in the online supplementary material to carry out the CTT. The failed samples of the test are shown in Figures 5 and 6.

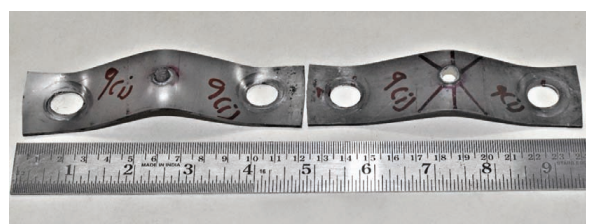
Figure 6. CTT-failed sample 9

clear indication of brittle failure, which is quite natural in the case of pull-out failure. Moreover, according to the literature, the nugget diameter of sample 9 is also clearly above the critical nugget diameter, which will eventually result in pull-out failure.²³

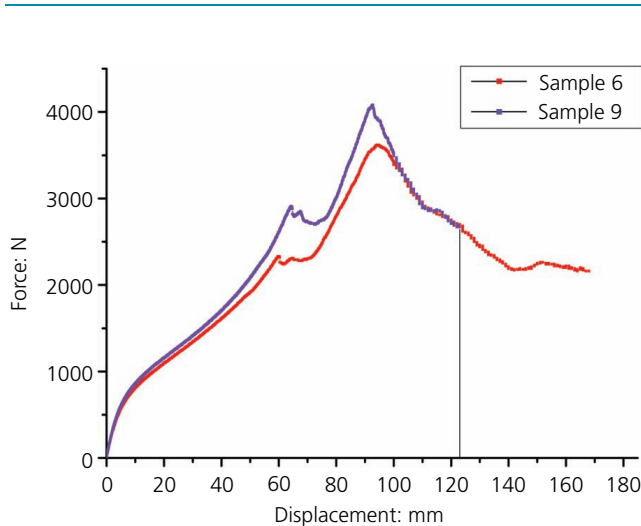
supplementary material. The ultimate forces absorbed by samples 6 and 9 during the test were 3.6 and 4 kN, respectively. The peak load absorbed in the CPT increased with the increasing welding current and heating cycles.²¹ The ruggedness of an automobile or any welded structure was purely reliant on the strength of the weld, and during the dynamic conditions of the structure, the load would be absorbed by the weld spots predominantly. Hence, it is very critical to ensure that the weld joints do not fail during the dynamic condition for any type of specimen arrangement. S11 in

Figure 10. Load-displacement curves of the CPT

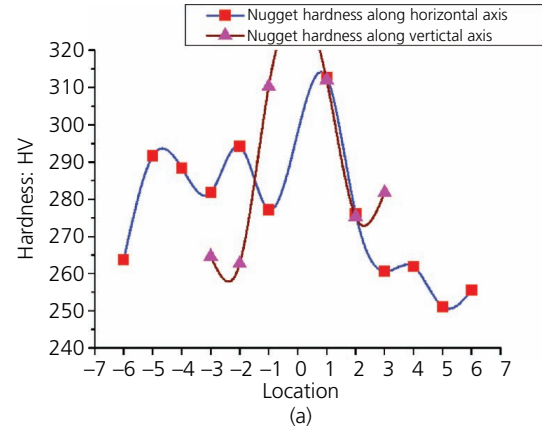
the nugget with a spacing of 0.5 mm between the indentations. In addition, the tests were done at three locations each on the AISI 347 and DSS 2205 base metals. Figure 11 shows the variation of the hardness of the weld nugget and the base metals. All specimens were tested in ambient air at room temperature. From the results, it is seen that the maximum hardness is recorded in the weld nugget zones, which confirms the quality of the weld properties tested in the CTT and CPT. The test results agree with the results of the microhardness testing of SS 304 weldments carried out by Kumar *et al.*²⁶ The distribution of the hardness values along the horizontal axis and vertical axis of the weld nugget shown in Figures 11(a) and 11(b) depicts the variation in hardness as the location is moved away from the centre of the weld nugget. The cooling rate of the weld pool plays a pivotal role in deciding the microstructural formation of the weld nugget.²⁷ The extremely faster cooling rates occurring during RSW cause the weld metal pool to undergo a much faster transition from the liquid phase to the ferritic phase and then to the austenitic phases. The cooling rate and the thermal conductivity of the base metals produce a combined effect on the variation of the hardness of the weld zone and the heat-affected

Figure 11. Hardness variation of the (a) weld nugget and (b) base metals

zone. The weld solidification cycle for DSS 2205 occurs in the order of liquid metal to δ -ferrite, and then in the temperature range 1200–800°C, the phases begin to change from ferritic to austenitic, and finally cooling below 500°C results in the formation of a matrix of various ferritic and austenitic phases.²⁸ The air cooling occurring during the weld cycle also causes ferritic phase formation in the solidification process. The ferritic formation during the later stages of solidification cycle improves the hardness of the weld zone relative to that of the base metal. The maximum hardness is seen in the centre of the weld nugget, and the hardness is minimised gradually moving towards the heat-affected zones of the parent metals along either of the axes. The hardness values of DSS 2205 are higher than those of the AISI 347 base metal, and hence, the initial tear progresses in AISI 347, which is softer than DSS. The hardness values are maximum in the fusion zone for the chosen sample,²⁹ and it is found to have failed under pull-out failure mode in the CTT and CPT. This is in poor concurrence with the research conducted on the RSW of dual-phase steel sheets wherein the samples that had maximum hardness in the fusion zone failed under interfacial failure mode.³⁰ This contrasting behaviour of the dissimilar RSW sample exhibits the characteristics of austenitic stainless steel and DSS against the dual-phase steel sheets.
