# ENERGY AUDIT REPORT FOR THE YEAR 2024.

**PERIYAR  
MANIAMMAI**

**Report Prepared By**

**Dr.M.Vivekanandan M.E.,Ph.D**

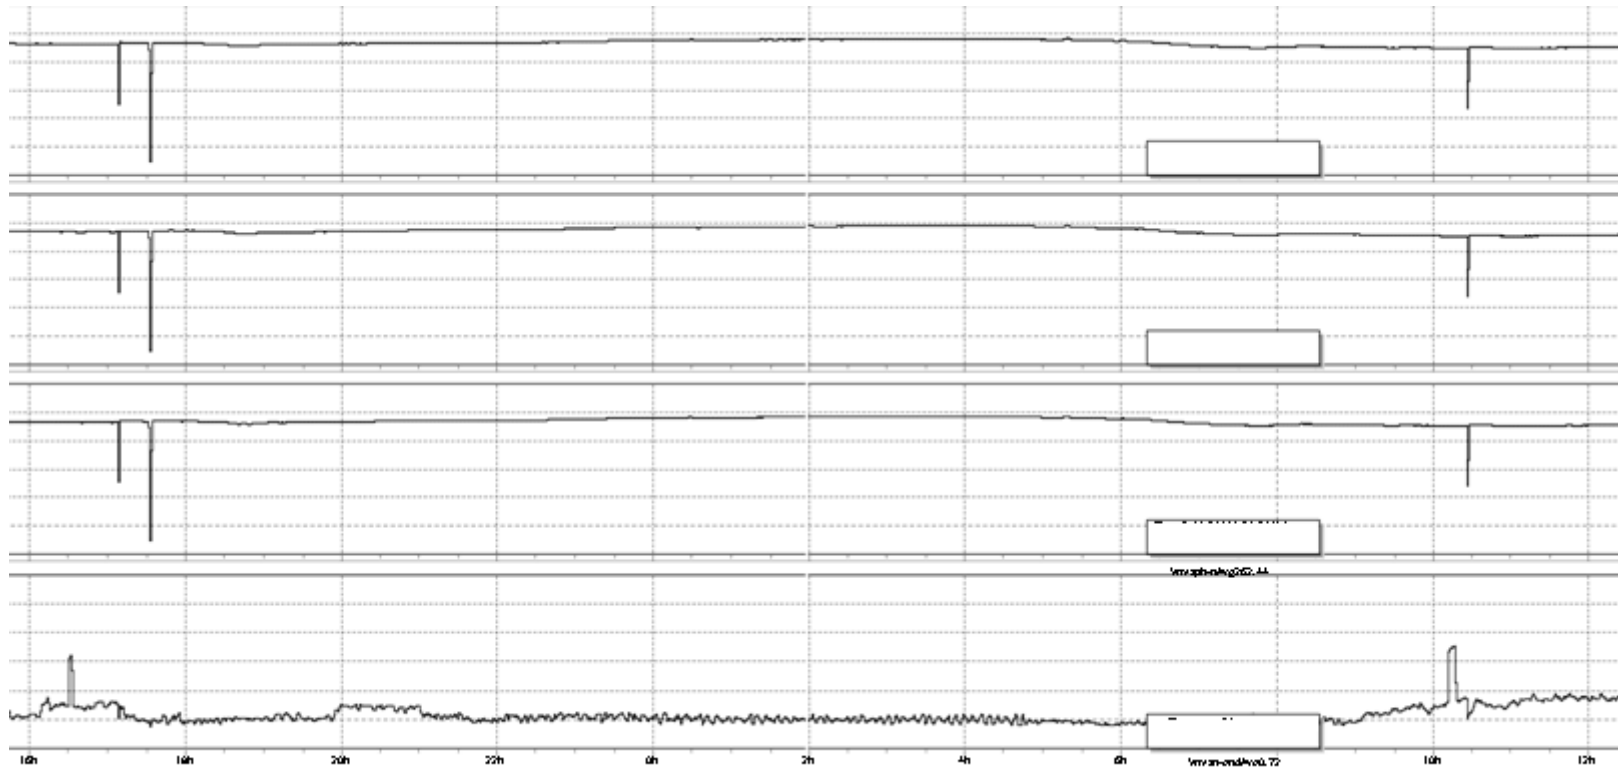
Fig.1 shows the voltage on three phases and Neutral to ground for 22 hour's from 20/03/2024 15:17 pm to 21/03/2024 12:50pm

Inference: There is no abnormalities found. Also, the neutral to ground voltage is well within the acceptable range of 5 Volt

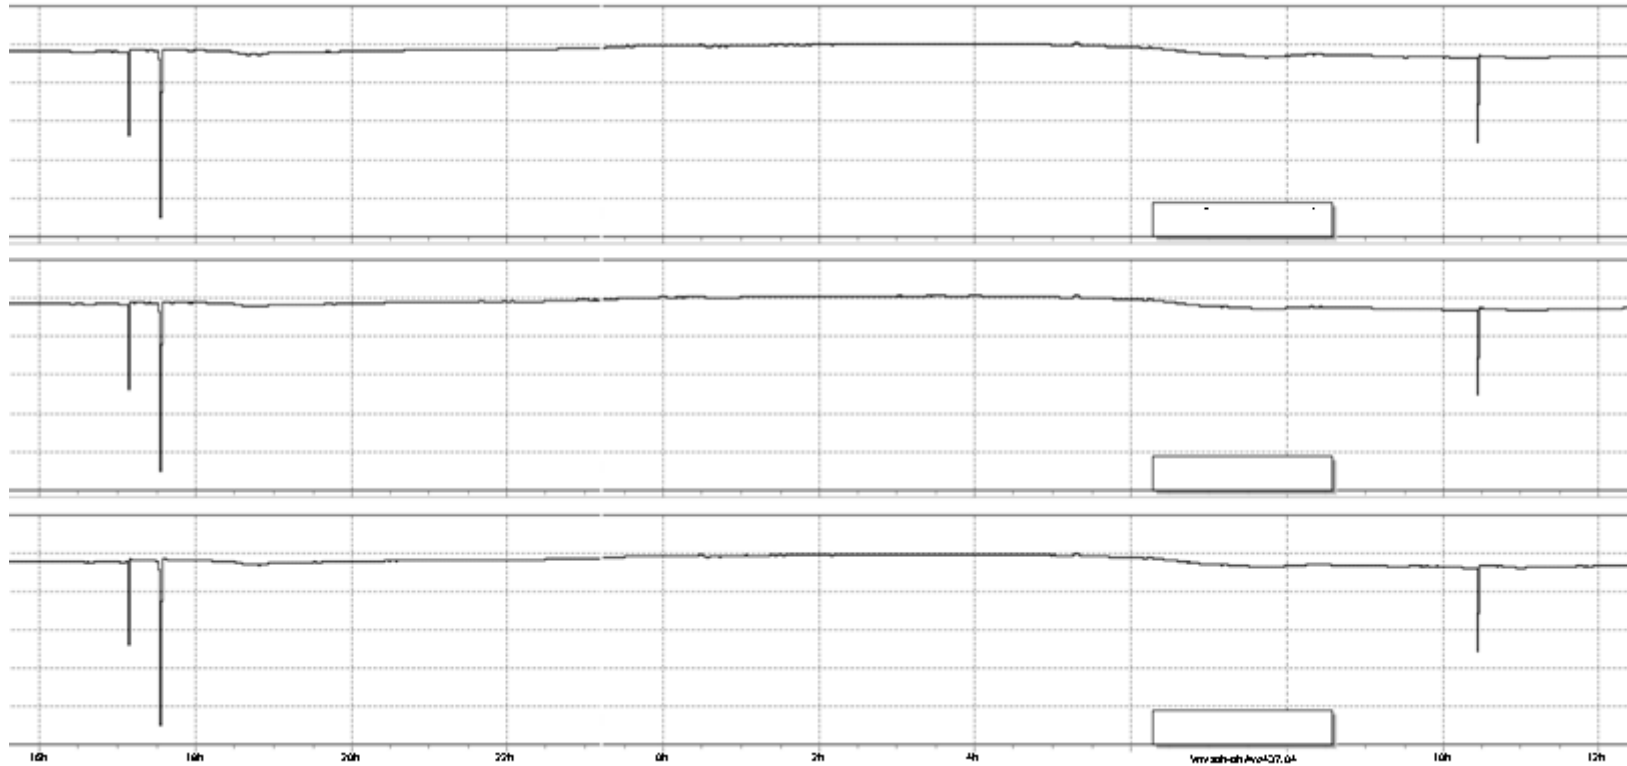
Fig.2 Shows the line to line voltage on three phases for 22 hours from 20/03/2024 15:17 pm to 21/03/2024 12:50pm

Inference :There is no abnormalities found.

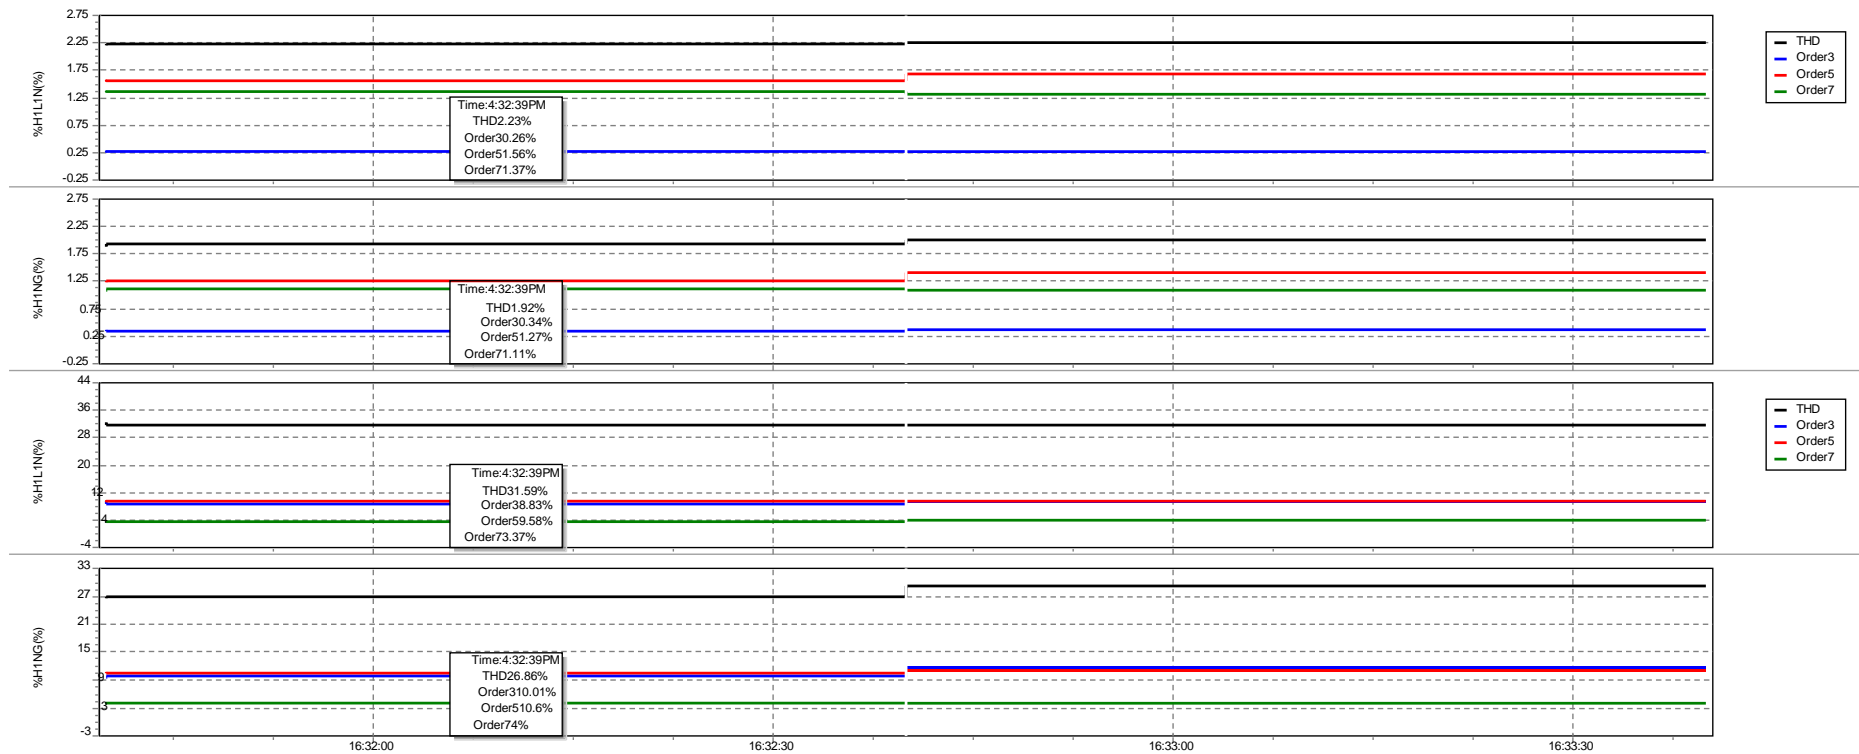
Fig.36 Shows the THD(Current) for LED Tube Light

Inference: Lower order harmonics are found in LED tube light and also THD is quite high.

Note: IEEE Std 519, "RECOMMENDED PRACTICES AND REQUIREMENTS FOR HARMONIC CONTROL IN ELECTRICAL POWER SYSTEMS" recommends only 5% of Total Harmonic Distortion (THD).

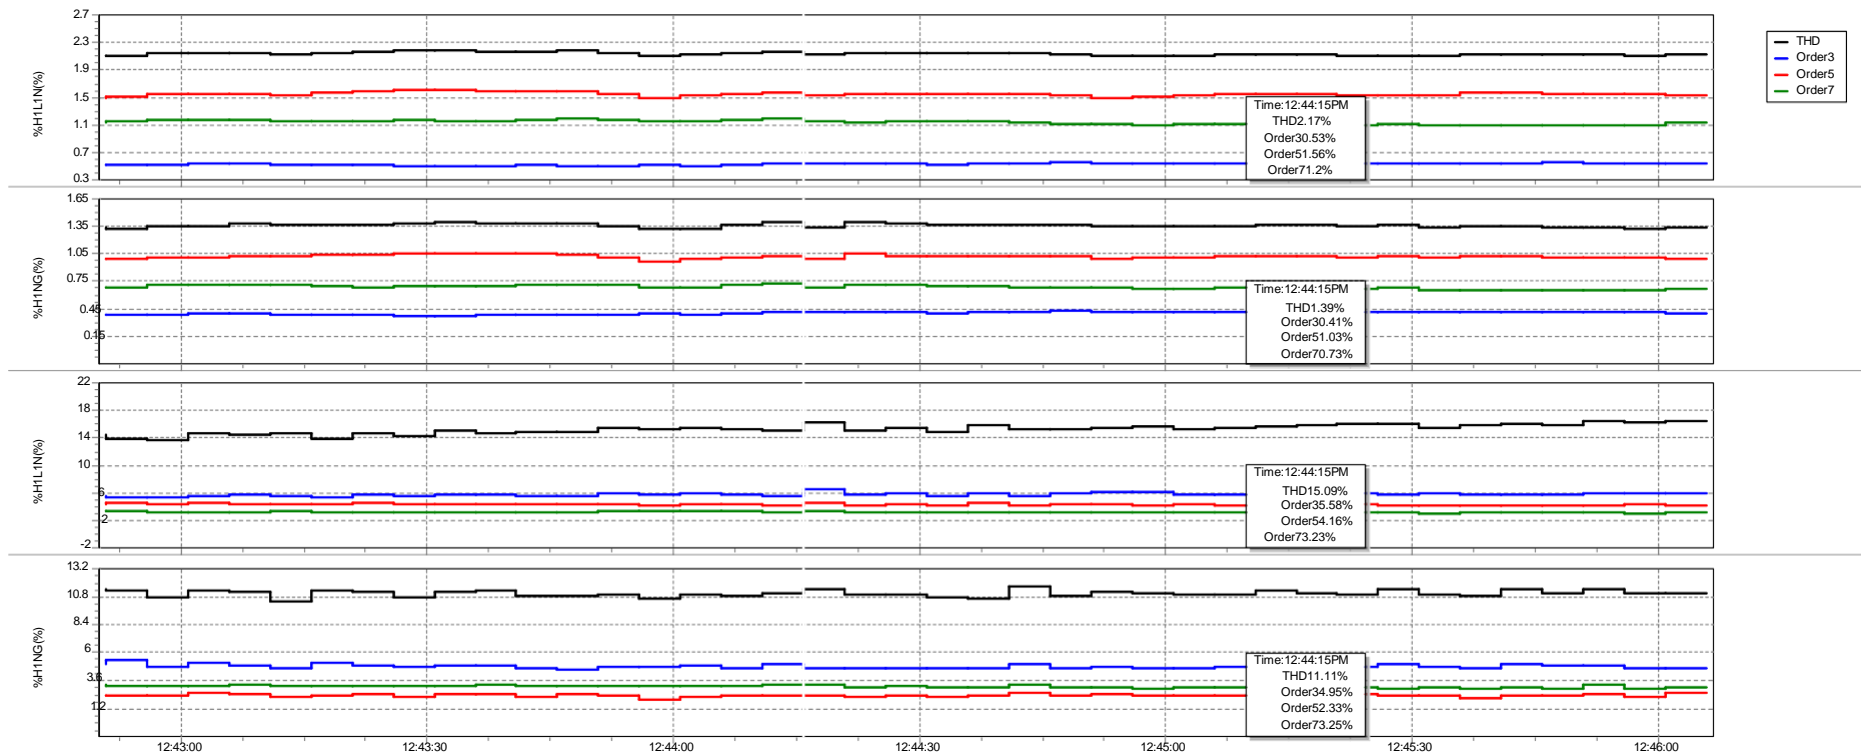
Fig.37 Shows the THD (Current) for Street Light

Inference :Lower order harmonics are found in Street Light and also THD is quite high.

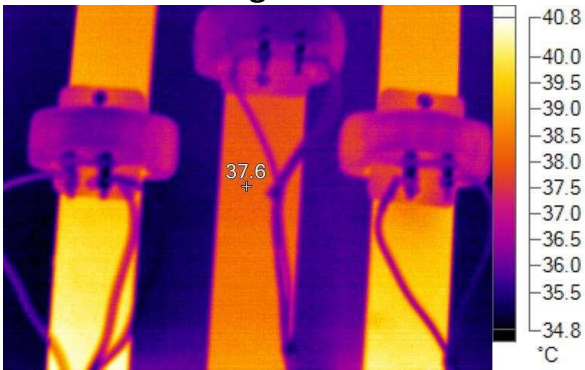
**IR000394.IS2**  
No abnormalities found.

**Main EB Incoming Panel**

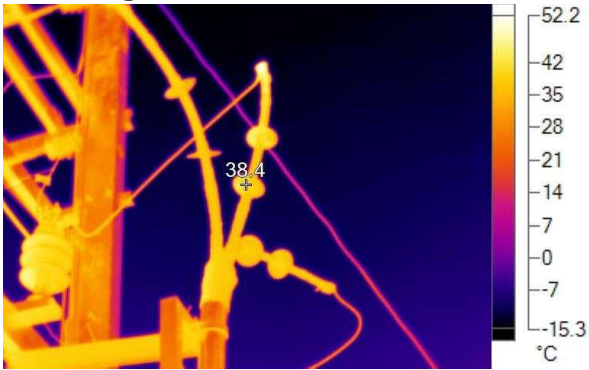
**IR000401.IS2**  
No abnormalities found.

**Incoming Feeder Near Entrance**

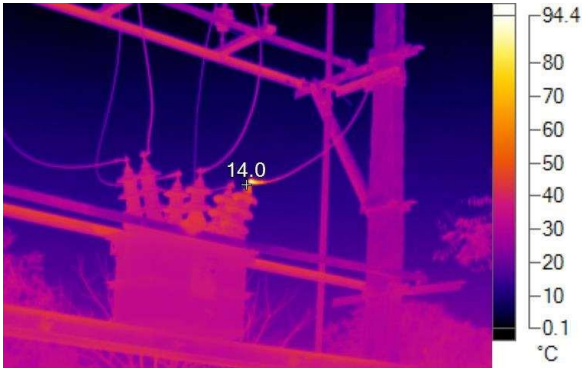
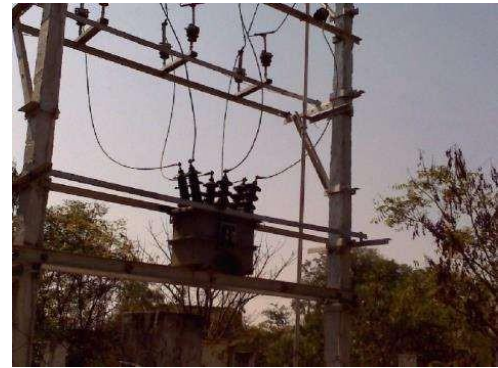
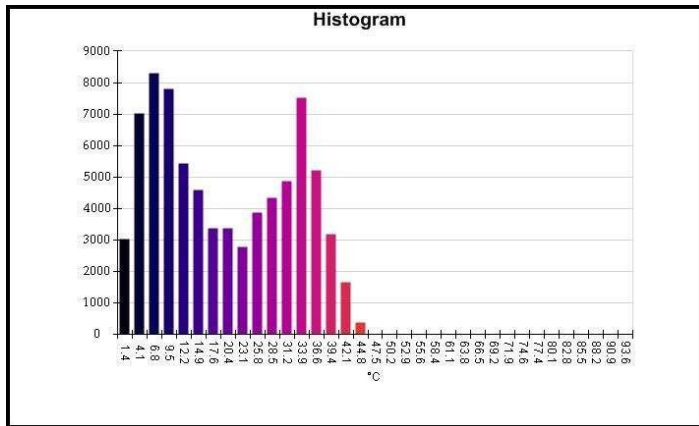
**IR000402.IS2**

**EB Transformer Near Entrance**

There is a loose connection in the incoming feeder, hence its Generates 90°C
